Limited Visual Dam Safety Inspection Summary Report

MA-071

Reservoir 21

May 2006

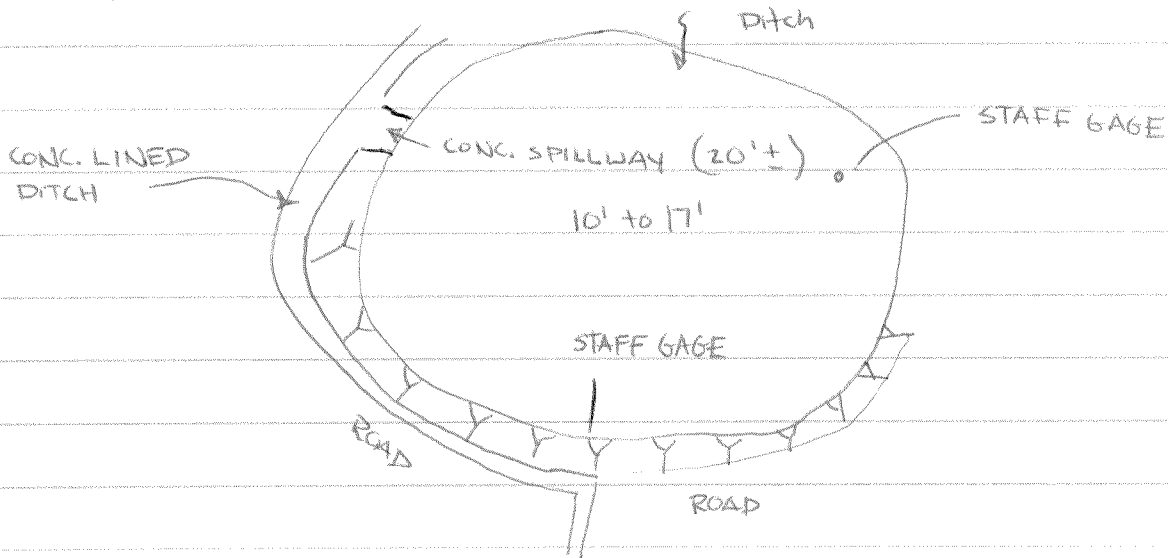
Reservoir is fed from the Kauhikoa ditch (controlled by wooden gate)
outlet works feeds irrigation ditch and/or drip irrigation system
concrete spillway discharges into a concrete lined ditch that runs
along the downstream slope toe. Kauhikoa
